Controls Upgrade (Intelligen™) and Tune-Up for Regenerative Combustion System

Application: Steel Reheat Furnace

Bloom provided a combustion system tune-up and controls upgrade on a reheat furnace that provided a **safer operation, better fuel rates, less scale loss and greater productivity** through the furnace.

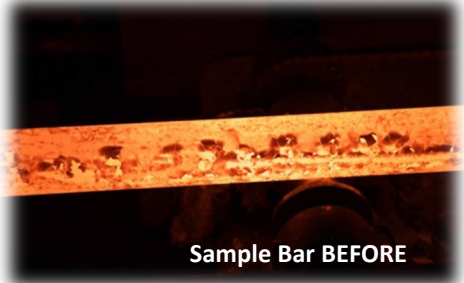
<p>Sample Bar BEFORE</p> </div> <div style="text-align: center;">

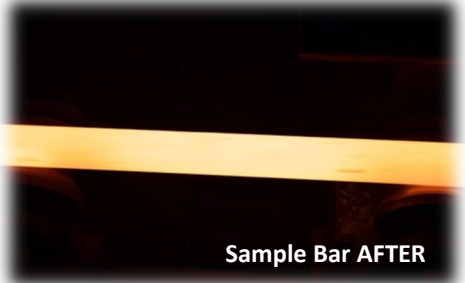
<p>Sample Bar AFTER</p> </div> </div>
